**Flood Control Project Maintenance
Levee Inspections**
LMA District Cover Sheet
Spring 2017 Levee Inspection Results

Reclamation District No. 0150 Merrit Island

Spring 2017 Levee Inspection Results

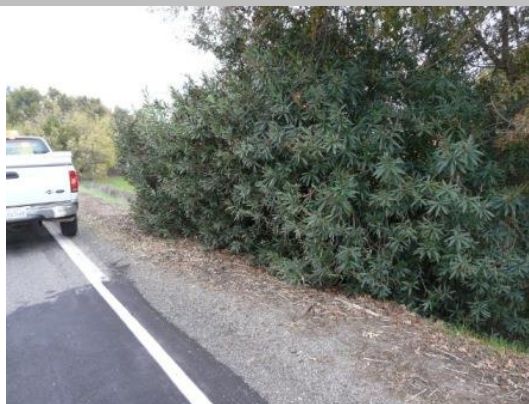
Photo 1 of 1 : SP_2017_RD0150_16_58_20170327_00031.jpg

LM Start	7.01	Rating **	M	Issue No.	58
LM End	7.01	Issue Type +	En	Location *	LS
Category	Earthen Levee			GPS Latitude/Longitude	
				Start	End
Item	Vegetation			38.403631 °	38.403631 °
				-121.516299 °	-121.516299 °
DWR ID	DWR_RD0150_02_s_2012_58				
Comment Code					
V6 : Landscaping					
Inspector Comment

Landscaping providing a screen for a residence on landside of levee at LM 7.12

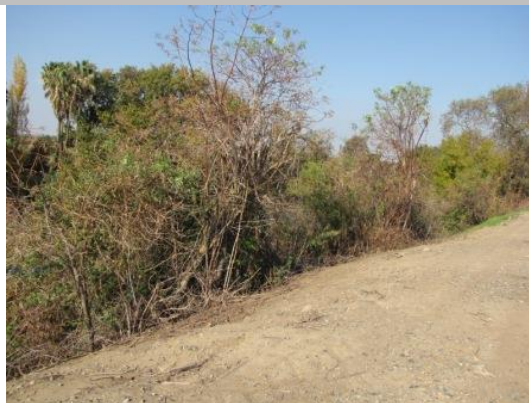
Photo 1 of 1 : SP_2017_RD0150_17_936_20170327_00089.jpg

LM Start	0.11	Rating **	M	Issue No.	936
LM End	0.11	Issue Type +	Ma	Location *	WS
Category	Earthen Levee			GPS Latitude/Longitude	
				Start	End
Item	Vegetation			38.334233 °	38.334233 °
				-121.583414 °	-121.583414 °
DWR ID	DWR_RD0150_03_s_2012_936				
Comment Code					
V4 : Elderberries are blocking visibility and flood fight capability.					
Inspector Comment					
Elderberries are partially blocking visibility.

View of elderberry bush within 20 feet of shoulder blocking visibility and access.

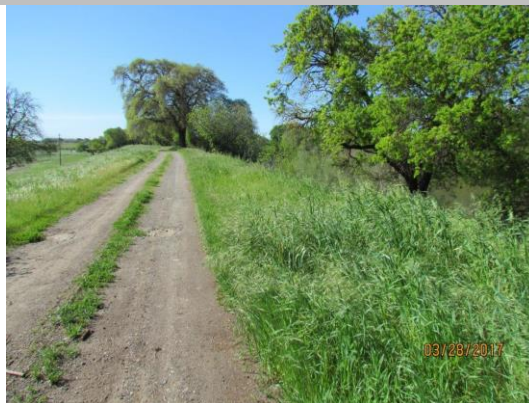
Photo 1 of 1 : SP_2017_RD0150_17_39_20170330_00135.jpg

LM Start	0.21	Rating **	M	Issue No.	39
LM End	0.62	Issue Type +	Ma	Location *	WS
Category	Earthen Levee			GPS Latitude/Longitude	
				Start	End
Item	Vegetation			38.335630 °	38.341228 °
				-121.582744 °	-121.580609 °
DWR ID	DWR_RD0150_03_s_2017_39				
Comment Code					
V1 : Control annual grass and weeds on the levee slopes and easements.					
Inspector Comment

View of the vegetation on the waterside slope of the levee looking downstream.

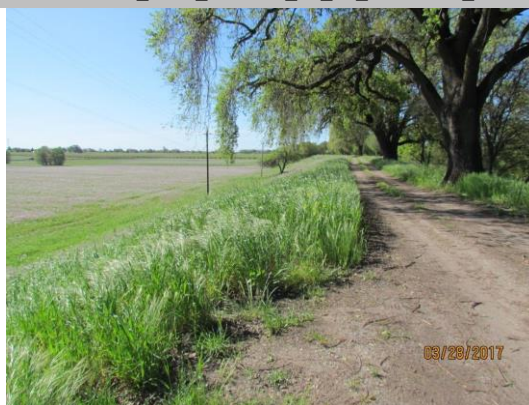
Photo 1 of 1 : SP_2017_RD0150_17_38_20170330_00134.jpg

LM Start	0.21	Rating **	M	Issue No.	38
LM End	0.63	Issue Type +	Ma	Location *	LS
Category	Earthen Levee			GPS Latitude/Longitude	
				Start	End
Item	Vegetation			38.335630 °	38.341390 °
				-121.582744 °	-121.580568 °
DWR ID	DWR_RD0150_03_s_2017_38				
Comment Code					
V1 : Control annual grass and weeds on the levee slopes and easements.					
Inspector Comment

View of the vegetation on the landside slope of the levee looking downstream.

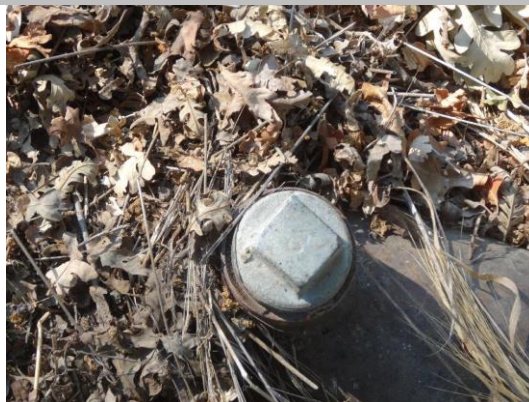
Photo 2 of 3 : UCIP_SP_2017_42694_32004.jpg

LM Start	0.39	Rating **	M	Issue No.	951
LM End	0.39	Issue Type +	En	Location *	LS
Category	Supplemental			GPS Latitude/Longitude	
				Start	End
Item	DWR UCIP Field Study			38.337928 °	38.337928 °
				-121.581496 °	-121.581496 °
DWR ID					
Comment Code					
Inspector Comment					
FS_ID:42694 DS_ID:22453 EP_NO: 13612 Repair Type: Non-Urgent Crossing Status: Found UCIP Comments: Abandoned. Proper abandone needs. FIELD_STRUCT_DESC: *ABANDONED* 6-inch steel pipe through the levee, 3.5 feet below the crown. Pump and gate valve on the waterward slope. FS Date: 8/20/2013

WS view: safety valve on steel pipe.

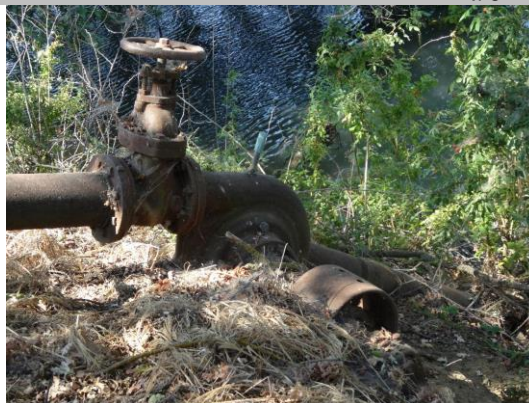
Photo 3 of 3 : UCIP_SP_2017_42694_32003.jpg

LM Start	0.39	Rating **	M	Issue No.	951 (cont)
LM End	0.39	Issue Type +	En	Location *	LS
Category	Supplemental			GPS Latitude/Longitude	
				Start	End
Item	DWR UCIP Field Study			38.337928 °	38.337928 °
				-121.581496 °	-121.581496 °
DWR ID					
Comment Code					
Inspector Comment					
FS_ID:42694 DS_ID:22453 EP_NO: 13612 Repair Type: Non-Urgent Crossing Status: Found UCIP Comments: Abandoned. Proper abandone needs. FIELD_STRUCT_DESC: *ABANDONED* 6-inch steel pipe through the levee, 3.5 feet below the crown. Pump and gate valve on the waterward slope. FS Date: 8/20/2013

WS view: abandoned pipe, gate valve, and pump on levee slope.

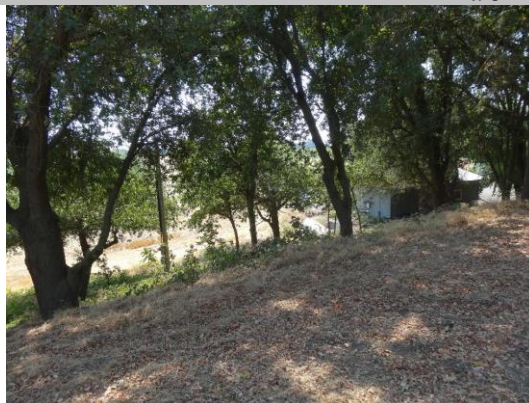
Photo 2 of 3 : UCIP_SP_2017_42693_31978.jpg

LM Start	0.40	Rating **	M	Issue No.	952 (cont)	
LM End	0.40	Issue Type +	En	Location *	LS	
Category	Supplemental			GPS Latitude/Longitude		
				Start	End	
Item	DWR UCIP Field Study			38.338131 °	38.338131 °	
				-121.581434 °	-121.581434 °	
DWR ID						
Comment Code						
Inspector Comment						
FS_ID:42693						
DS_ID:22454						
EP_NO: N/A						
Repair Type: Non-Urgent						
Crossing Status: Found						
UCIP Comments: Seems to be abandoned. Service pole on LS slope.						
1" conduit through levee.May need proper abandonment.						
FIELD_STRUCT_DESC: 6-inch steel pipe through the levee, 3.5 feet below the crown. Pump and gate valve on the waterward slope.						
FS Date: 8/20/2013

LS view: no pipe on levee slope.

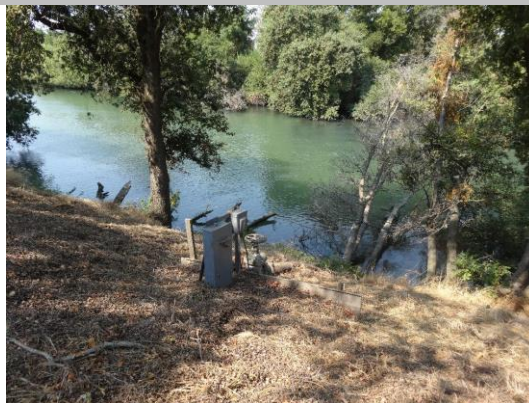
Photo 3 of 3 : UCIP_SP_2017_42693_31977.jpg

WS view: pipe and pump on levee slope.

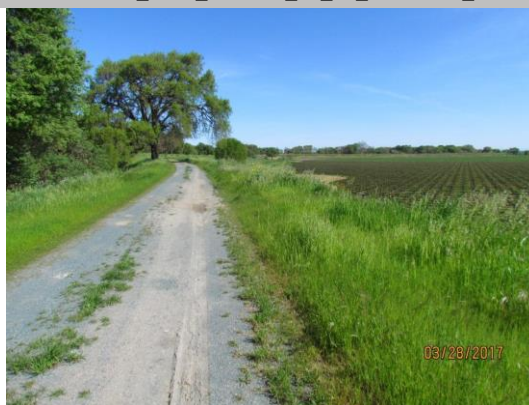
Photo 1 of 1 : SP_2017_RD0150_17_42_20170330_00136.jpg

LM Start	0.66	Rating **	M	Issue No.	42
LM End	2.93	Issue Type +	Ma	Location *	LS
Category	Earthen Levee			GPS Latitude/Longitude	
				Start	End
Item	Vegetation			38.341843 °	38.362112 °
				-121.580413 °	-121.562268 °
DWR ID	DWR_RD0150_03_s_2017_42				
Comment Code					
V1 : Control annual grass and weeds on the levee slopes and easements.					
Inspector Comment

View of the vegetation on the landside slope of the levee looking upstream.

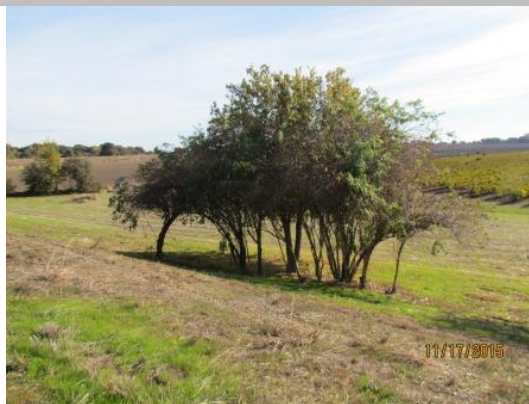
Photo 1 of 1 : SP_2017_RD0150_17_5_20170327_00001.jpg

LM Start	0.92	Rating **	M	Issue No.	5
LM End	0.92	Issue Type +	Ma	Location *	LS
Category	Earthen Levee			GPS Latitude/Longitude	
				Start	End
Item	Vegetation			38.345493 °	38.345493 °
				-121.579682 °	-121.579682 °
DWR ID	DWR_RD0150_03_s_2012_5				
Comment Code					
V4 : Elderberries are blocking visibility and flood fight capability.					
Inspector Comment					
Elderberries are partially blocking visibility.

View of elderberries on the landward slope of the levee.

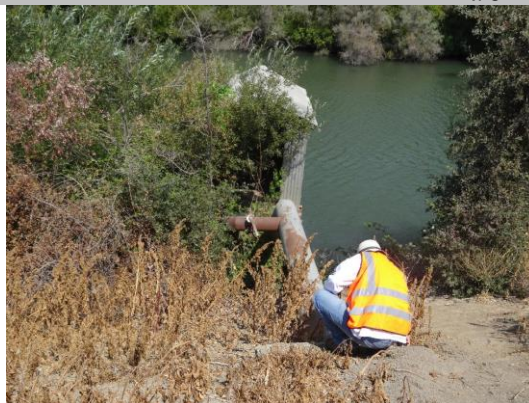
Photo 1 of 3 : UCIP_SP_2017_19112_32044.jpg

FS_ID:19112
DS_ID:22433
EP_NO: N/A
Repair Type: Non-Urgent
Crossing Status: Found
UCIP Comments: No handrail on wooden walkway.
FIELD_STRUCT_DESC: 14-inch steel pipe through the levee, 8.0 feet below the crown, pump in pump house on the waterward slope. Service pole and steel distribution box on the landward slope.
FS Date: 8/20/2013

WS view: pipe on levee slope and pump house in channel.

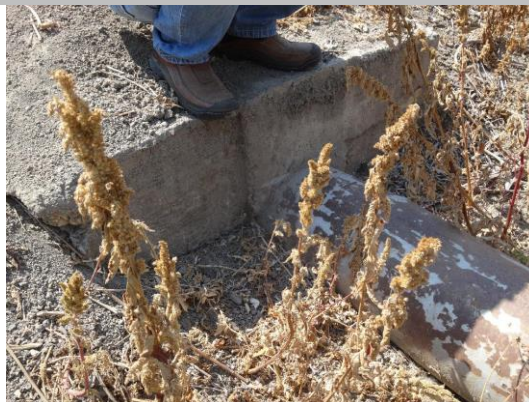
Photo 2 of 3 : UCIP_SP_2017_19112_32043.jpg

WS view: concrete headwall and exposed pipe on levee slope.

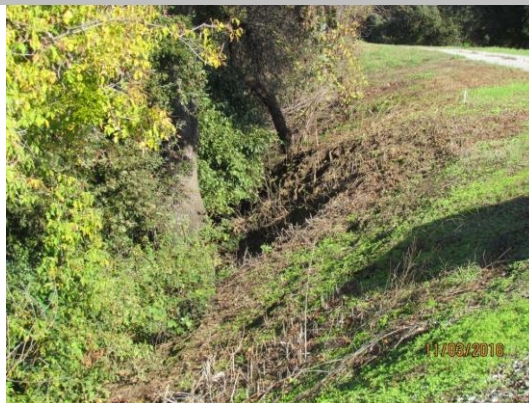
Photo 1 of 1 : SP_2017_RD0150_17_70_20170327_00051.jpg

LM Start	1.42	Rating **	M	Issue No.	70
LM End	1.42	Issue Type +	Ob	Location *	WS
Category	Earthen Levee			GPS Latitude/Longitude	
				Start	End
Item	Erosion / Bank Caving			38.348132 °	38.348132 °
				-121.572368 °	-121.572368 °
DWR ID	DWR_RD0150_03_f_2016_70				
Comment Code					
E1 : Note and monitor erosion site.					
Inspector Comment

View of an erosion on the waterside slope of the levee. Fall 2016

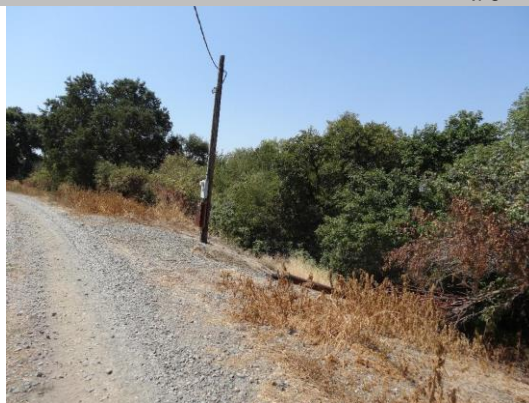
Photo 1 of 3 : UCIP_SP_2017_19137_32108.jpg

LM Start	1.78	Rating **	M	Issue No.	954
LM End	1.78	Issue Type +	En	Location *	WS
Category	Supplemental			GPS Latitude/Longitude	
				Start	End
Item	DWR UCIP Field Study			38.353180 °	38.353180 °
				-121.572907 °	-121.572907 °
DWR ID					
Comment Code					
Inspector Comment					
FS_ID:19137 DS_ID:22434 EP_NO: N/A Repair Type: Non-Urgent Crossing Status: Found UCIP Comments: Small depression on WS slope due to leak from pump. Pipe opens on LS ditch/depression. FIELD_STRUCT_DESC: 10-inch pipe through the levee, 3.4 feet below the crown, pump, gate valve and service pole on the waterward slope. FS Date: 8/20/2013

WS view: exposed pipe and power pole on levee slope.

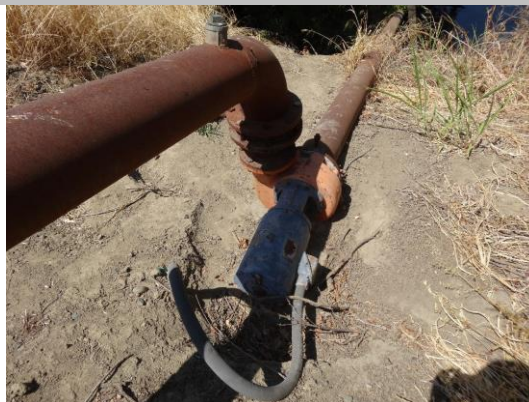
Photo 3 of 3 : UCIP_SP_2017_19137_32106.jpg

WS view: pipe and slant pump on levee slope.

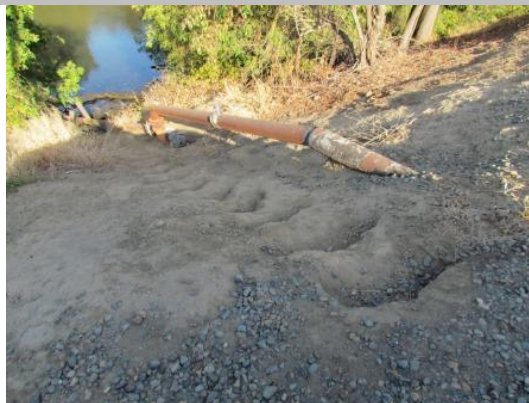
Photo 1 of 1 : SP_2017_RD0150_17_50_20170327_00032.jpg

LM Start	1.78	Rating **	M	Issue No.	50
LM End	1.78	Issue Type +	En	Location *	WS
Category	Earthen Levee			GPS Latitude/Longitude	
				Start	End
Item	Encroachments			38.353249 °	38.353249 °
				-121.572848 °	-121.572848 °
DWR ID	DWR_RD0150_03_s_2012_50				
Comment Code					
ST : Stairway					
Inspector Comment					
Stairs are dug next to the pipe.

Steps were dug next to the pipe and also erosion was found near the vicinity of the pipe on the waterside slope of the levee looking upstream.

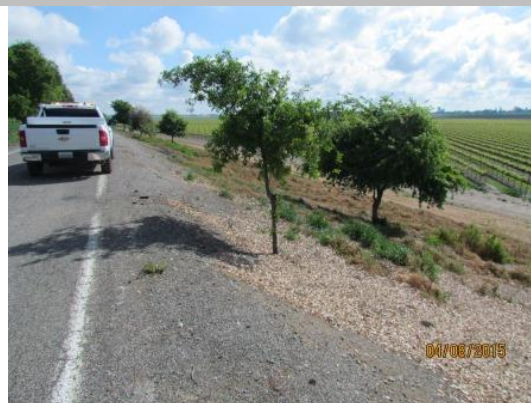
Photo 1 of 4 : SP_2017_RD0150_17_78_20170327_00056.jpg

LM Start	2.31	Rating **	M	Issue No.	78
LM End	2.31	Issue Type +	Ma	Location *	LS
Category	Earthen Levee			GPS Latitude/Longitude	
				Start	End
Item	Trim / Thin Trees			38.354286 °	38.354286 °
				-121.564494 °	-121.564494 °
DWR ID	DWR_RD0150_03_s_2012_78				
Comment Code					
T2 : Thin trees to allow visibility of the ground and room to flood fight.					
Inspector Comment					
New tree was planted on the landside slope.

Updated picture of the trees on the landside of the levee during spring 2015 inspection.

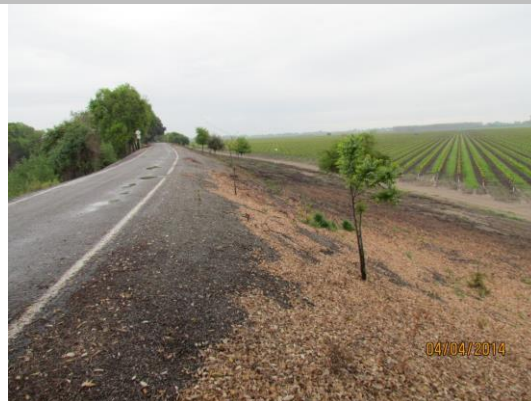
Photo 2 of 4 : SP_2017_RD0150_17_78_20170327_00057.jpg

View of the newly planted tree on the landside slope of the levee during spring 2014 inspection.

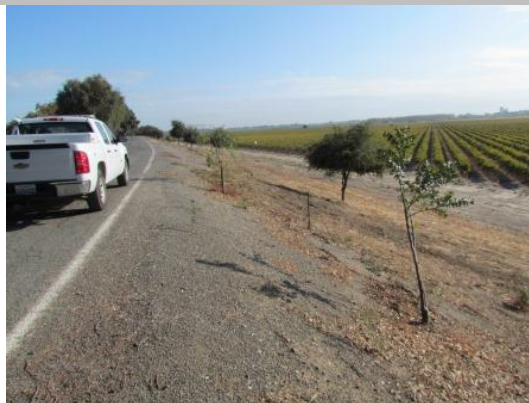
Photo 3 of 4 : SP_2017_RD0150_17_78_20170327_00058.jpg

LM Start	2.31	Rating **	M	Issue No.	78 (cont)	
LM End	2.31	Issue Type +	Ma	Location *	LS	
Category	Earthen Levee			GPS Latitude/Longitude		
				Start		End
Item	Trim / Thin Trees			38.354286 °		38.354286 °
				-121.564494 °		-121.564494 °
DWR ID	DWR_RD0150_03_s_2012_78					
Comment Code						
T2 : Thin trees to allow visibility of the ground and room to flood fight.						
Inspector Comment						
New tree was planted on the landside slope.

Several newly planted trees were found on the landside slope of the levee looking upstream during the fall 2013 inspection.

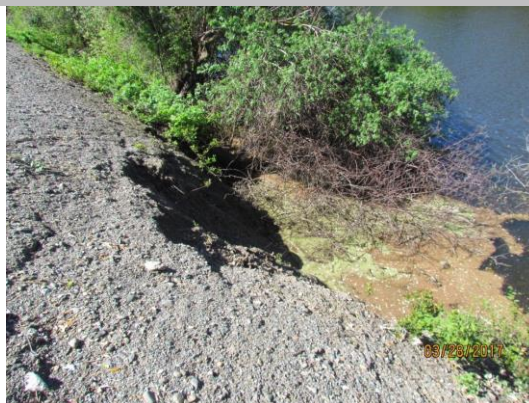
Photo 1 of 1 : SP_2017_RD0150_17_54_20170330_00138.jpg

LM Start	2.52	Rating **	M	Issue No.	54
LM End	2.52	Issue Type +	Ma	Location *	WS
Category	Earthen Levee			GPS Latitude/Longitude	
				Start	End
Item	Erosion / Bank Caving			38.356398 °	38.356398 °
				-121.561834 °	-121.561834 °
DWR ID	DWR_RD0150_03_s_2017_54				
Comment Code					
E2 : Schedule repair of erosion site prior to the next inspection.					
Inspector Comment

View of an erosion on the waterside slope of the levee looking downstream.

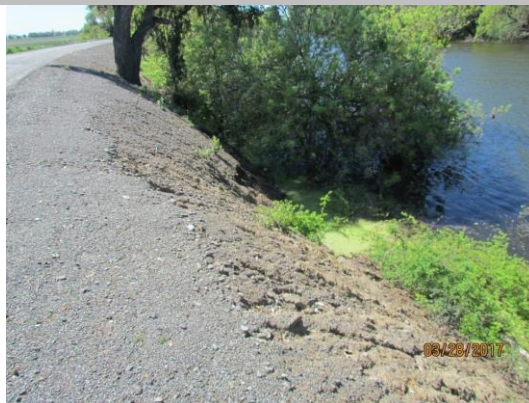
Photo 1 of 1 : SP_2017_RD0150_17_62_20170330_00139.jpg

LM Start	2.75	Rating **	M	Issue No.	62
LM End	2.75	Issue Type +	Ma	Location *	WS
Category	Earthen Levee			GPS Latitude/Longitude	
				Start	End
Item	Slope Stability			38.359693 °	38.359693 °
				-121.561354 °	-121.561354 °
DWR ID	DWR_RD0150_03_s_2017_62				
Comment Code					
S1 : Repair slope instability.					
Inspector Comment					
Run off due to rain.

View of slope instability on the waterside slope of the levee looking downstream.

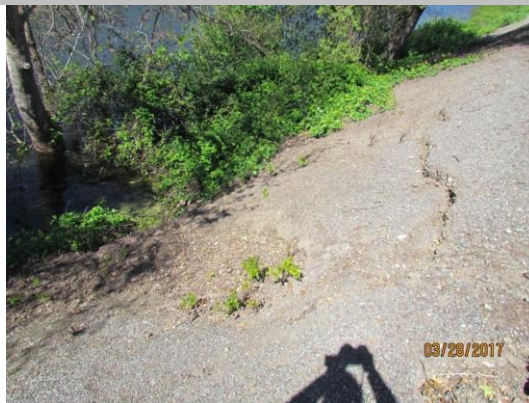
Photo 1 of 2 : SP_2017_RD0150_17_35_20170330_00141.jpg

LM Start	2.80	Rating **	M	Issue No.	35
LM End	2.80	Issue Type +	Ma	Location *	WS
Category	Earthen Levee			GPS Latitude/Longitude	
				Start	End
Item	Erosion / Bank Caving			38.360432 °	38.360432 °
				-121.561644 °	-121.561644 °
DWR ID	DWR_RD0150_03_s_2013_35				
Comment Code					
E2 : Schedule repair of erosion site prior to the next inspection.					
Inspector Comment

Updated picture of the erosion on the waterside of the levee during spring 2017 inspection.

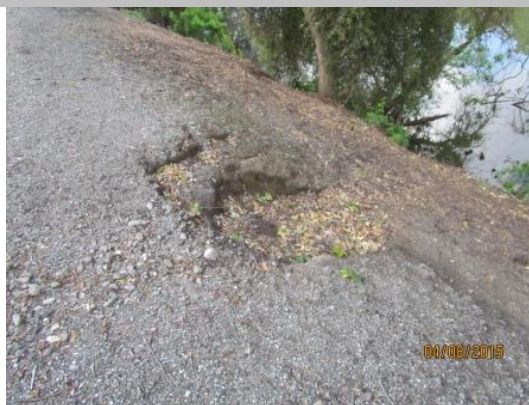
Photo 2 of 2 : SP_2017_RD0150_17_35_20170327_00021.jpg

View of the erosion on the waterside of the levee during spring 2015 inspection.

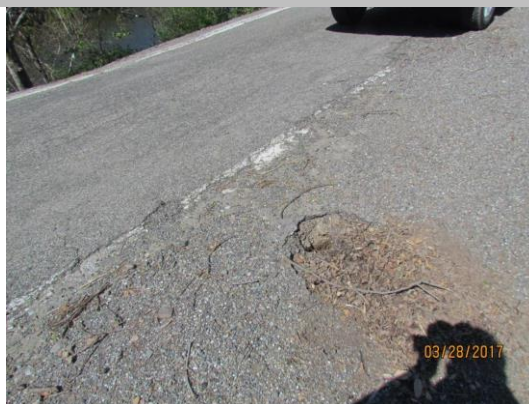
Photo 1 of 1 : SP_2017_RD0150_17_71_20170330_00140.jpg

LM Start	2.81	Rating **	M	Issue No.	71
LM End	2.81	Issue Type +	Ma	Location *	CR
Category	Earthen Levee			GPS Latitude/Longitude	
				Start	End
Item	Animal Control			38.360477 °	38.360477 °
				-121.561625 °	-121.561625 °
DWR ID	DWR_RD0150_03_s_2017_71				
Comment Code					
A3 : No rodents visible, but rodent burrows visible; need to backfill and compact or grout burrows.					
Inspector Comment

View of a rodent hole on the landside shoulder of the levee looking upstream.

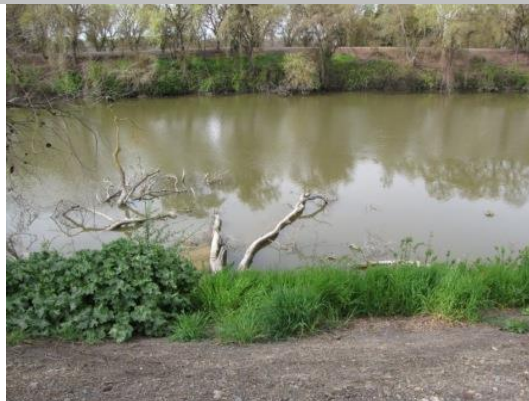
Photo 1 of 1 : SP_2017_RD0150_17_17_20170327_00009.jpg

LM Start	2.82	Rating **	N	Issue No.	17
LM End	2.82	Issue Type +	Ma	Location *	WS
Category	Earthen Levee			GPS Latitude/Longitude	
				Start	End
Item	Trim / Thin Trees			38.360621 °	38.360621 °
				-121.561762 °	-121.561762 °
DWR ID	DWR_RD0150_03_s_2012_17				
Comment Code					
T5 : Tree stumps.					
Inspector Comment

View of tree stumps on the waterward slope.

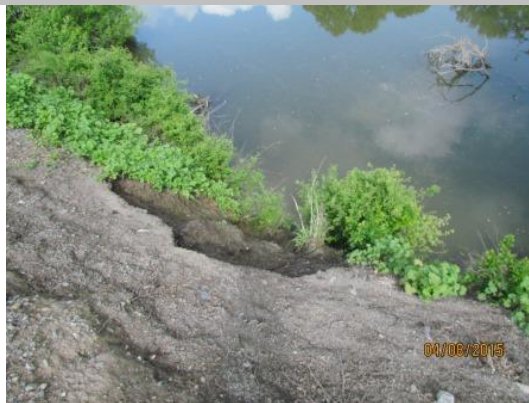
Photo 1 of 2 : SP_2017_RD0150_17_40_20170327_00025.jpg

LM Start	3.31	Rating **	M	Issue No.	40
LM End	3.31	Issue Type +	Ob	Location *	WS
Category	Earthen Levee			GPS Latitude/Longitude	
				Start	End
Item	Erosion / Bank Caving			38.363008 °	38.363008 °
				-121.556751 °	-121.556751 °
DWR ID	DWR_RD0150_03_s_2013_40				
Comment Code					
E2 : Schedule repair of erosion site prior to the next inspection.					
Inspector Comment

Updated picture of the erosion on the waterside of the levee during spring 2015 inspection.

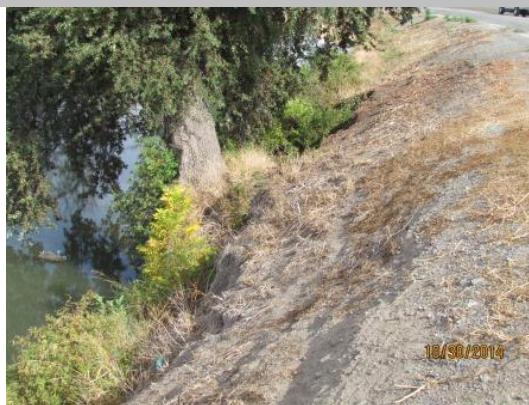
Photo 2 of 2 : SP_2017_RD0150_17_40_20170327_00026.jpg

Updated picture of the erosion on the waterside of the levee looking upstream during fall 2014 inspection.

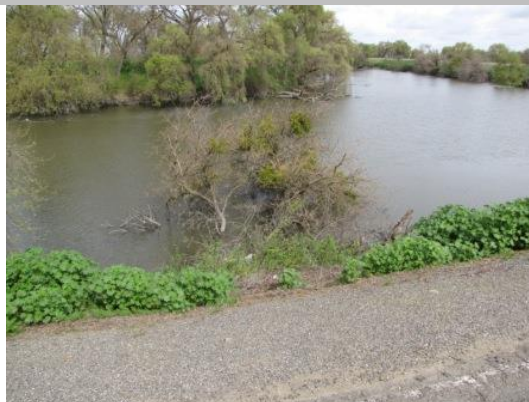
Photo 1 of 1 : SP_2017_RD0150_17_27_20170327_00014.jpg

LM Start	3.34	Rating **	N	Issue No.	27
LM End	3.34	Issue Type +	Ma	Location *	WS
Category	Earthen Levee			GPS Latitude/Longitude	
				Start	End
Item	Trim / Thin Trees			38.363147 °	38.363147 °
				-121.556190 °	-121.556190 °
DWR ID	DWR_RD0150_03_s_2012_27				
Comment Code					
T5 : Tree stumps.					
Inspector Comment

View of tree stumps on the waterside slope looking upstream.

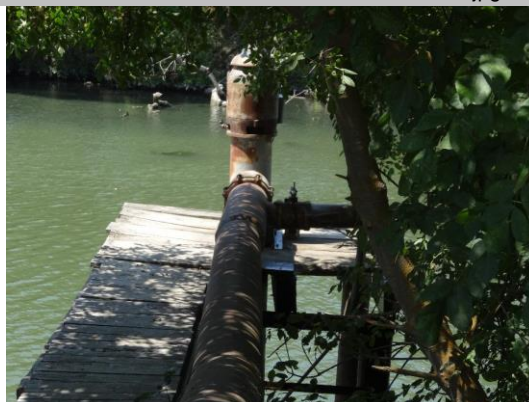
Photo 2 of 3 : UCIP_SP_2017_51467_35012.jpg

WS view: steel pipe & pump, walkway, pump support in the channel.

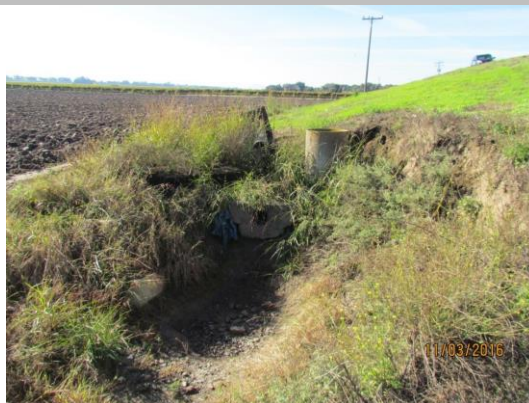
Photo 1 of 3 : SP_2017_RD0150_17_115_20170327_00079.jpg

LM Start	3.39	Rating **	U	Issue No.	115
LM End	3.39	Issue Type +	Ma	Location *	LS
Category	Earthen Levee			GPS Latitude/Longitude	
				Start	End
Item	Erosion / Bank Caving			38.363540 °	38.363540 °
				-121.555554 °	-121.555554 °
DWR ID	DWR_RD0150_03_f_2013_115				
Comment Code					
E2 : Schedule repair of erosion site prior to the next inspection.					
Inspector Comment					
Erosion (ditch) was found on the landside toe of the levee.

Updated picture of the ditch on the landside toe of the levee. Fall 2016

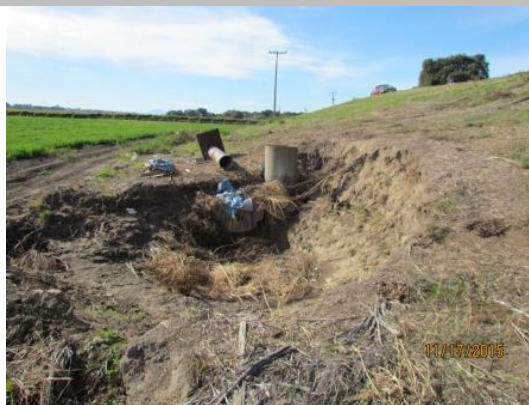
Photo 2 of 3 : SP_2017_RD0150_17_115_20170327_00080.jpg

Updated picture of the ditch on the landside toe of the levee during fall 2015 inspection.

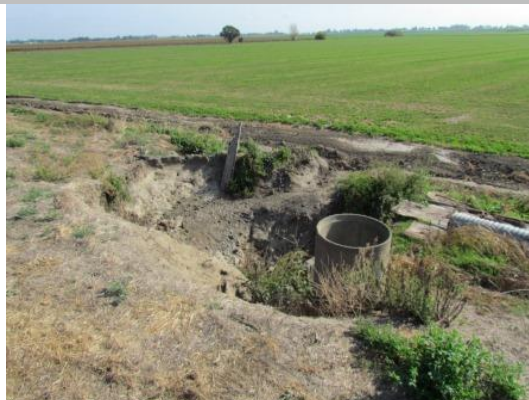
Photo 3 of 3 : SP_2017_RD0150_17_115_20170327_00081.jpg

A drainage ditch with depth of 4 feet and width of 15 feet was found on the landside toe of the levee. The picture was taken from the landside slope looking upstream during the fall 2013 inspection.

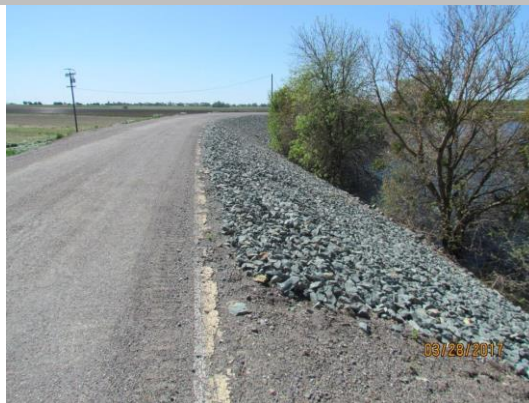
Photo 1 of 1 : SP_2017_RD0150_17_76_20170330_00142.jpg

LM Start	3.45	Rating **	A/W	Issue No.	76
LM End	3.45	Issue Type +	Ma	Location *	WS
Category	Earthen Levee			GPS Latitude/Longitude	
				Start	End
Item	Riprap Revetments			38.364325 °	38.364325 °
				-121.555330 °	-121.555330 °
DWR ID	DWR_RD0150_03_s_2017_76				
Comment Code					
Inspector Comment					
LMA or the pipe owner has placed new riprap on the waterside slope.

View of the new riprap on the waterside slope of the levee looking downstream. Spring 2017

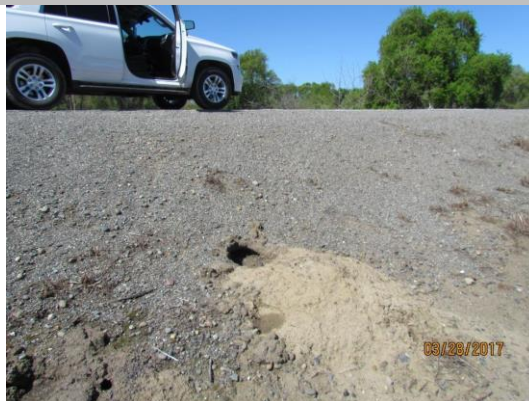
Photo 1 of 1 : SP_2017_RD0150_17_77_20170330_00143.jpg

LM Start	3.56	Rating **	M	Issue No.	77
LM End	3.56	Issue Type +	Ma	Location *	LS
Category	Earthen Levee			GPS Latitude/Longitude	
				Start	End
Item	Animal Control			38.365899 °	38.365899 °
				-121.555611 °	-121.555611 °
DWR ID	DWR_RD0150_03_s_2017_77				
Comment Code					
A3 : No rodents visible, but rodent burrows visible; need to backfill and compact or grout burrows.					
Inspector Comment

View of an animal burrow on the landside slope of the levee.

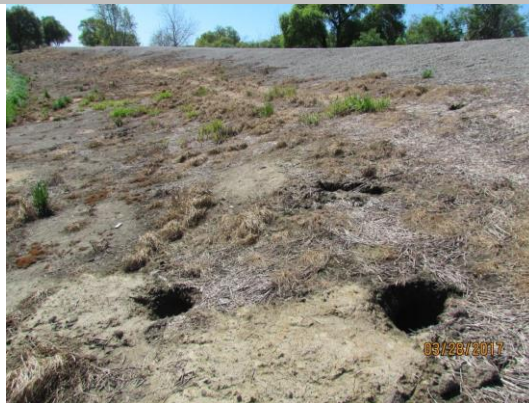
Photo 1 of 1 : SP_2017_RD0150_17_86_20170330_00144.jpg

LM Start	3.61	Rating **	U	Issue No.	86
LM End	3.61	Issue Type +	Ma	Location *	LS
Category	Earthen Levee			GPS Latitude/Longitude	
				Start	End
Item	Animal Control			38.366688 °	38.366688 °
				-121.555749 °	-121.555749 °
DWR ID	DWR_RD0150_03_s_2017_86				
Comment Code					
A3 : No rodents visible, but rodent burrows visible; need to backfill and compact or grout burrows.					
Inspector Comment					
Animal hole dug by most probably a fox.

View of multiple rodent holes on the landside of the levee looking downstream.

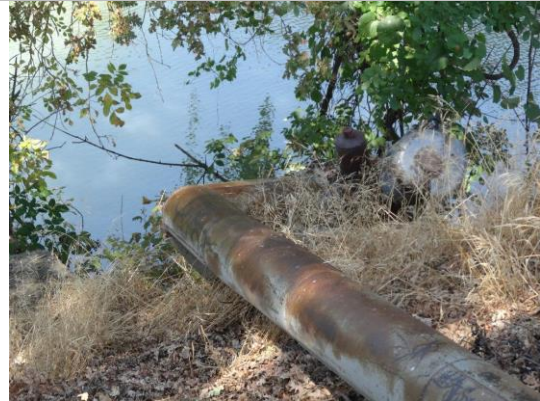
Photo 1 of 3 : UCIP_SP_2017_50202_35018.jpg

FS_ID:50202
DS_ID:22440
EP_NO: N/A
Repair Type: Non-Urgent
Crossing Status: Found
UCIP Comments: 07/07/2016: Unable to locate evidence of major depression of WS slope. Only slight depression on WS slope above pump. Though this is an up-and-over pipe, no positive closure device found. Inlet in LS standpipe is capped with a board. If no longer in use, needs to be abandoned properly. Siphon breaker/vent on WS needs a cover. Wave-wash run-up along river bank characteristic of much of Elk Slough. Crossing has been downgraded from Urgent to Non-Urgent. (K. Fazel - UCIP)08/20/2013:Levee damage.Gate valve on WS not found. (P. Amatya - DWR)
FIELD_STRUCT_DESC: 12-inch steel irrigation pipe through the levee, 5.9 feet below the crown. Slant pump on the waterside (WS) slope. Vent/siphon breaker at the apex of the pipe on the WS. A concrete platform lies next to the pump on the WS. Concrete standpipe and service pole with meter at the landside (LS) toe. Property owner is Ken Pylman at 916-775-1066 [Additional Reference(s): DWR Levee Log, 2005. USACE Sacramento O&M Manual 112, March 1957 (HLM 3.73)].

WS view: steel pipe and pump on levee slope.

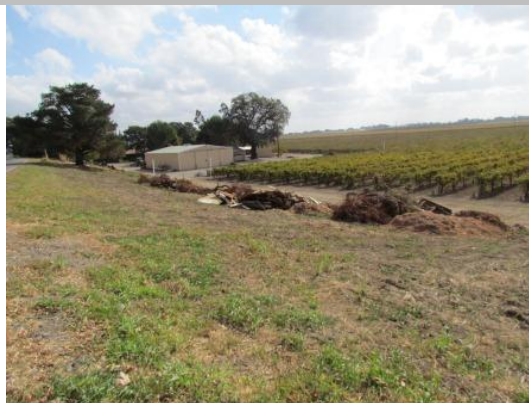
Photo 1 of 1 : SP_2017_RD0150_17_51_20170327_00033.jpg

LM Start	4.38	Rating **	M	Issue No.	51
LM End	4.38	Issue Type +	En	Location *	LS
Category	Earthen Levee			GPS Latitude/Longitude	
				Start	End
Item	Encroachments			38.374269 °	38.374269 °
				-121.549385 °	-121.549385 °
DWR ID	DWR_RD0150_03_s_2012_51				
Comment Code					
PR : Prunings					
Inspector Comment

Updated picture of the pruning pile on the landside of the levee looking upstream during the fall 2013 inspection.

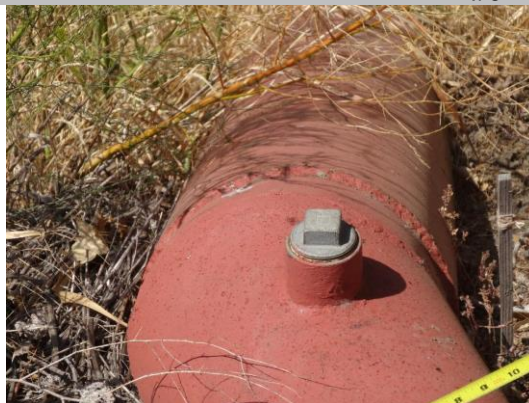
Photo 3 of 3 : UCIP_SP_2017_19281_32539.jpg

WS view: safety valve on steel pipe.

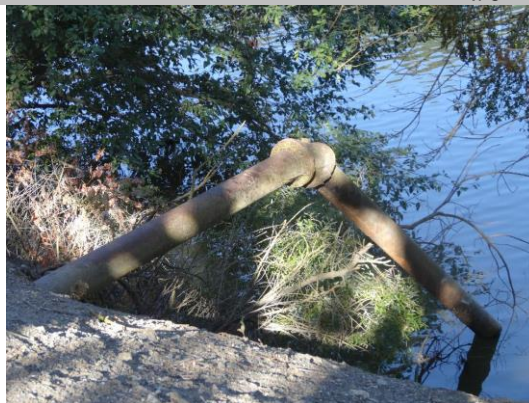
Photo 1 of 3 : UCIP_SP_2017_19283_32565.jpg

LM Start	4.90	Rating **	M	Issue No.	958
LM End	4.90	Issue Type +	En	Location *	WS
Category	Supplemental			GPS Latitude/Longitude	
				Start	End
Item	DWR UCIP Field Study			38.377718 °	38.377718 °
				-121.541413 °	-121.541413 °
DWR ID					
Comment Code					
Inspector Comment					
FS_ID:19283 DS_ID:22445 EP_NO: N/A Repair Type: Non-Urgent Crossing Status: Found UCIP Comments: - seems abandoned.- may need proper abandonment FIELD_STRUCT_DESC: *ABANDONED* 10-inch steel irrigation pipe through the levee, 7.2 feet below the crown. Gate valve on the landside (LS) end. [Additional References: DWR Levee Log, 2005. USACE Sacramento O&M Manual 112, March 1957 (RM 4.99)] FS Date: 8/23/2013

WS view: steel pipe on levee slope and in the stream.

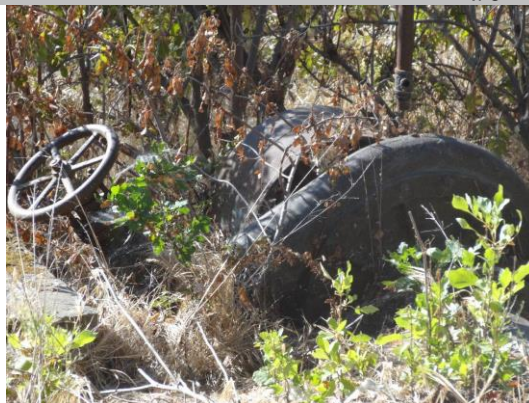
Photo 3 of 3 : UCIP_SP_2017_19283_32563.jpg

LS view: abandoned pump and gate valve on levee slope.

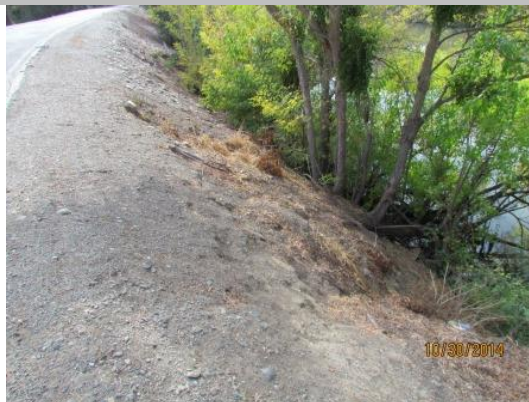
Photo 1 of 1 : SP_2017_RD0150_17_81_20170327_00061.jpg

LM Start	5.05	Rating **	M	Issue No.	81
LM End	5.05	Issue Type +	Ob	Location *	WS
Category	Earthen Levee			GPS Latitude/Longitude	
				Start	End
Item	Erosion / Bank Caving			38.379608 °	38.379608 °
				-121.540082 °	-121.540082 °
DWR ID	DWR_RD0150_03_f_2014_81				
Comment Code					
E2 : Schedule repair of erosion site prior to the next inspection.					
Inspector Comment

View of erosion on the waterside of the levee looking downstream.

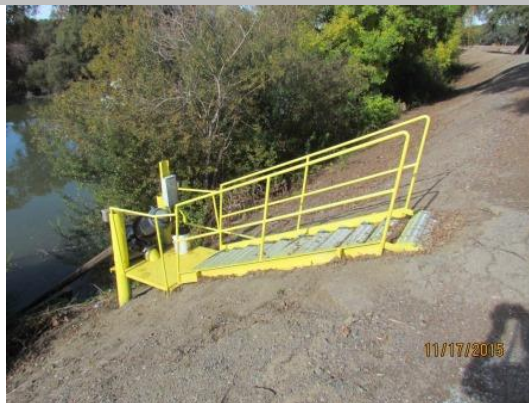
Photo 1 of 1 : SP_2017_RD0150_17_48_20170327_00030.jpg

LM Start	5.09	Rating **	M	Issue No.	48
LM End	5.09	Issue Type +	En	Location *	WS
Category	Earthen Levee			GPS Latitude/Longitude	
				Start	End
Item	Encroachments			38.380110 °	38.380110 °
				-121.540061 °	-121.540061 °
DWR ID	DWR_RD0150_03_f_2015_48				
Comment Code					
ST : Stairway					
Inspector Comment					
Unpermitted stairway.

View of a stairway on the waterside of the levee.

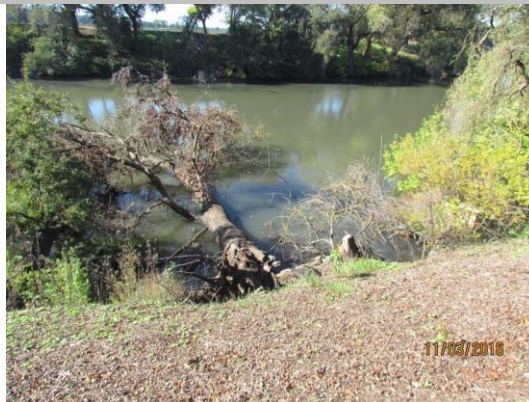
Photo 1 of 1 : SP_2017_RD0150_17_72_20170327_00052.jpg

LM Start	5.15	Rating **	M	Issue No.	72
LM End	5.15	Issue Type +	Ma	Location *	WS
Category	Earthen Levee			GPS Latitude/Longitude	
				Start	End
Item	Encroachments			38.380940 °	38.380940 °
				-121.540384 °	-121.540384 °
DWR ID	DWR_RD0150_03_f_2016_72				
Comment Code					
TR : Tree or limb					
Inspector Comment					
Tree stump and broken tree was found on the waterside toe.

View of tree stump and broken tree on the waterside toe of the levee.
Fall 2016

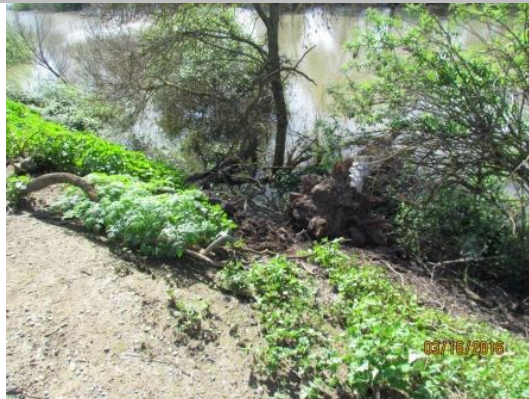
Photo 1 of 1 : SP_2017_RD0150_17_96_20170327_00075.jpg

LM Start	5.32	Rating **	M	Issue No.	96
LM End	5.32	Issue Type +	Ma	Location *	WS
Category	Earthen Levee			GPS Latitude/Longitude	
				Start	End
Item	Encroachments			38.381843 °	38.381843 °
				-121.543117 °	-121.543117 °
DWR ID	DWR_RD0150_03_s_2016_96				
Comment Code					
TR : Tree or limb					
Inspector Comment					
Broken tree/root damaged levee slope.

Broken tree roots and tree trunks were found on the waterside toe of the levee.

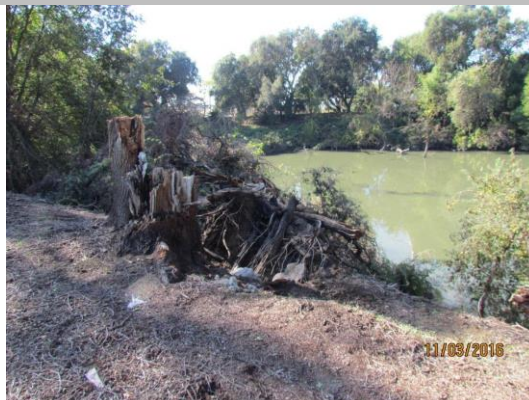
Photo 1 of 1 : SP_2017_RD0150_17_74_20170327_00054.jpg

LM Start	5.49	Rating **	N	Issue No.	74
LM End	5.49	Issue Type +	Ma	Location *	WS
Category	Earthen Levee			GPS Latitude/Longitude	
				Start	End
Item	Trim / Thin Trees			38.383051 °	38.383051 °
				-121.545735 °	-121.545735 °
DWR ID	DWR_RD0150_03_f_2016_74				
Comment Code					
T5 : Tree stumps.					
Inspector Comment					
Tree stump and broken tree was found on the waterside shoulder of the levee.

View of tree trunks on the waterside shoulder of the levee. Fall 2016

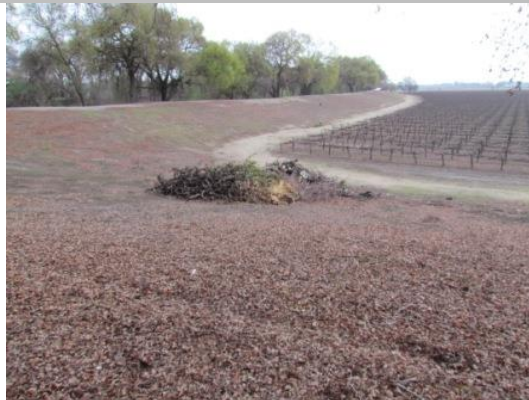
Photo 1 of 2 : SP_2017_RD0150_17_12_20170327_00005.jpg

LM Start	5.51	Rating **	M	Issue No.	12
LM End	5.51	Issue Type +	En	Location *	LS
Category	Earthen Levee			GPS Latitude/Longitude	
				Start	End
Item	Encroachments			38.383328 °	38.383328 °
				-121.545825 °	-121.545825 °
DWR ID	DWR_RD0150_03_s_2012_12				
Comment Code					
PR : Prunings					
Inspector Comment

Prunings were found on the landside of the levee looking upstream.

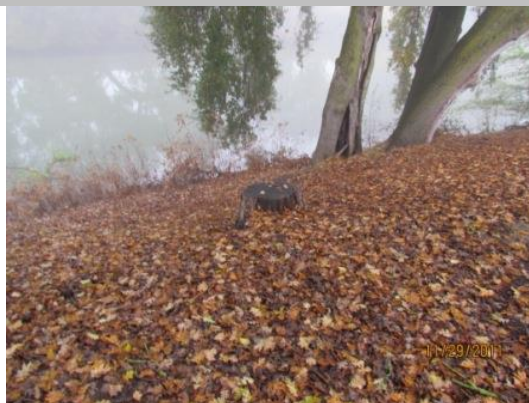
Photo 1 of 1 : SP_2017_RD0150_17_68_20170327_00050.jpg

LM Start	5.56	Rating **	N	Issue No.	68
LM End	5.56	Issue Type +	Ma	Location *	WS
Category	Earthen Levee			GPS Latitude/Longitude	
				Start	End
Item	Trim / Thin Trees			38.383697 °	38.383697 °
				-121.545201 °	-121.545201 °
DWR ID	DWR_RD0150_03_s_2012_68				
Comment Code					
T5 : Tree stumps.					
Inspector Comment

Tree stump was found on the waterside of the levee looking upstream.

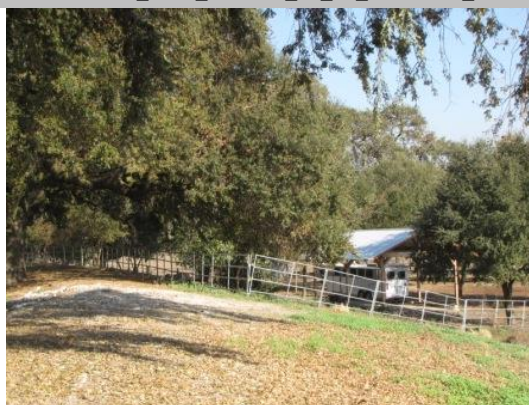
Photo 1 of 1 : SP_2017_RD0150_17_56_20170327_00037.jpg

LM Start	5.79	Rating **	M	Issue No.	56
LM End	5.83	Issue Type +	En	Location *	LS
Category	Earthen Levee			GPS Latitude/Longitude	
				Start	End
Item	Encroachments			38.384363 °	38.384796 °
				-121.541161 °	-121.540525 °
DWR ID	DWR_RD0150_03_s_2012_56				
Comment Code					
FE : Fence					
Inspector Comment

View of fence around a horse pen along the shoulder of the levee and the landward slope.

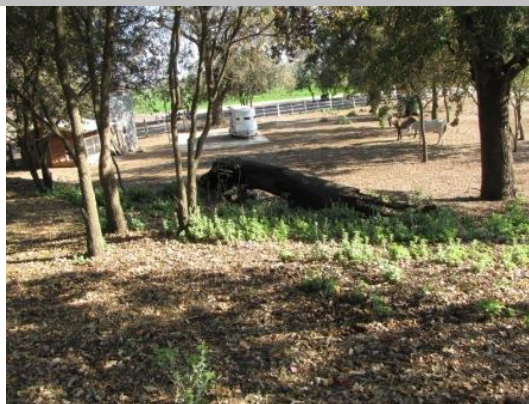
Photo 1 of 1 : SP_2017_RD0150_17_57_20170327_00038.jpg

LM Start	5.82	Rating **	M	Issue No.	57
LM End	5.82	Issue Type +	Ma	Location *	LS
Category	Earthen Levee			GPS Latitude/Longitude	
				Start	End
Item	Encroachments			38.384648 °	38.384648 °
				-121.540669 °	-121.540669 °
DWR ID	DWR_RD0150_03_s_2012_57				
Comment Code					
TR : Tree or limb					
Inspector Comment

View of a tree trunk lying on the landward slope blocking visibility.

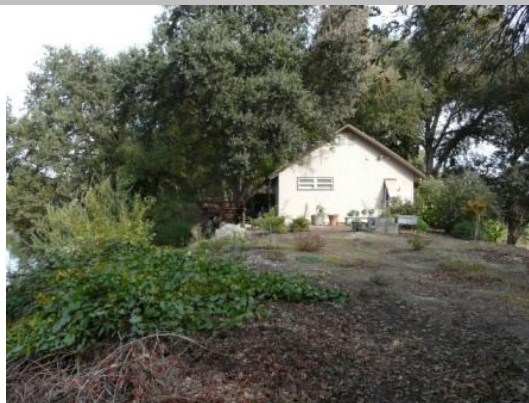
Photo 1 of 1 : SP_2017_RD0150_17_58_20170327_00039.jpg

LM Start	5.83	Rating **	U	Issue No.	58
LM End	5.83	Issue Type +	En	Location *	CR
Category	Earthen Levee			GPS Latitude/Longitude	
				Start	End
Item	Encroachments			38.384803 °	38.384803 °
				-121.540545 °	-121.540545 °
DWR ID	DWR_RD0150_03_s_2012_58				
Comment Code					
BU : Building					
Inspector Comment					
Permit 7517-A covers this area, but more research is needed.

Building & associated landscaping on levee crown.

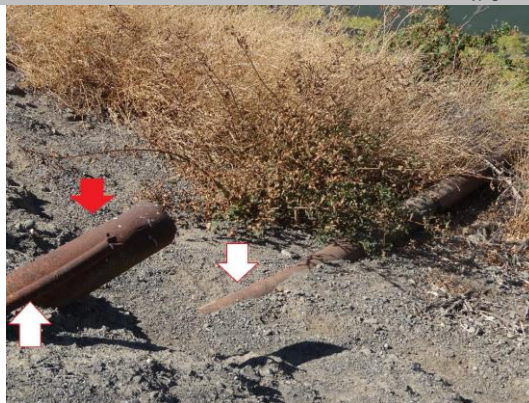
Photo 1 of 3 : UCIP_SP_2017_19403_32942.jpg

LM Start	5.95	Rating **	M	Issue No.	961
LM End	5.95	Issue Type +	En	Location *	LS
Category	Supplemental			GPS Latitude/Longitude	
				Start	End
Item	DWR UCIP Field Study			38.386402 °	38.386402 °
				-121.539834 °	-121.539834 °
DWR ID					
Comment Code					
Inspector Comment					
FS_ID:19403					
DS_ID:22451					
EP_NO: N/A					
Repair Type: Non-Urgent					
Crossing Status: Found					
UCIP Comments: - pipe ends open on both sides of the levee.- abandoned concrete box on WS.- two abandoned steel pipes (6" and 1") also found on WS. - needs proper abandonment					
FIELD_STRUCT_DESC: *ABANDONED* 6-inch steel pipe through the levee, 2.5 feet below the crown. Power pole on the landward slope. (W. Bogle). O&M Manual SAC 112, March 1957.					
FS Date: 8/23/2013

WS view: open ended 6" steel pipe (top-left), 1" steel pipe (bottom), and another 6" steel pipe (right) on levee slope.

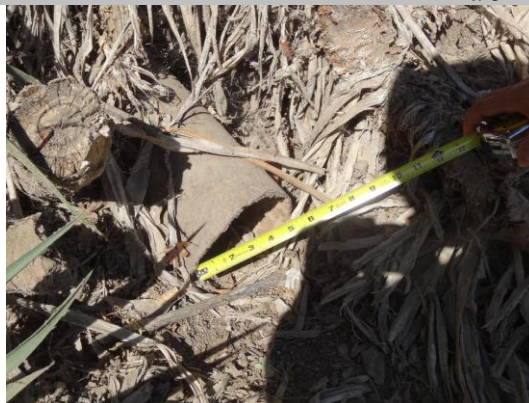
Photo 3 of 3 : UCIP_SP_2017_19403_32943.jpg

LM Start	5.95	Rating **	M	Issue No.	961 (cont)	
LM End	5.95	Issue Type +	En	Location *	LS	
Category	Supplemental			GPS Latitude/Longitude		
				Start	End	
Item	DWR UCIP Field Study			38.386402 °	38.386402 °	
				-121.539834 °	-121.539834 °	
DWR ID						
Comment Code						
Inspector Comment						
FS_ID:19403						
DS_ID:22451						
EP_NO: N/A						
Repair Type: Non-Urgent						
Crossing Status: Found						
UCIP Comments: - pipe ends open on both sides of the levee.-						
abandoned concrete box on WS.- two abandoned steel pipes (6" and						
1") also found on WS. - needs proper abandonment						
FIELD_STRUCT_DESC: *ABANDONED* 6-inch steel pipe through the						
levee, 2.5 feet below the crown. Power pole on the landward slope. (W.						
Bogle). O&M Manual SAC 112, March 1957.						
FS Date: 8/23/2013

LS view: open end steel pipe on levee toe.

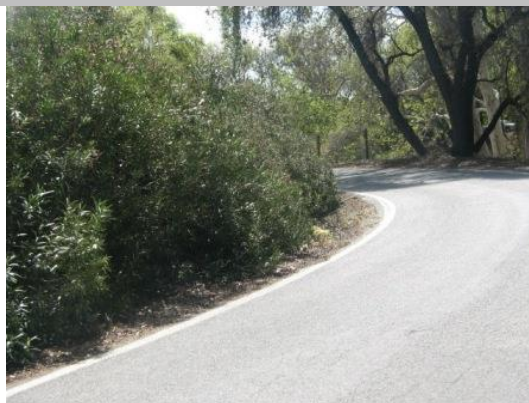
Photo 1 of 1 : SP_2017_RD0150_17_24_20170327_00012.jpg

LM Start	6.13	Rating **	U	Issue No.	24
LM End	6.20	Issue Type +	En	Location *	LS
Category	Earthen Levee			GPS Latitude/Longitude	
				Start	End
Item	Vegetation			38.388535 °	38.389391 °
				-121.541657 °	-121.541901 °
DWR ID	DWR_RD0150_03_s_2012_24				
Comment Code					
V6 : Landscaping					
Inspector Comment

Oleander on landward slope blocking view of levee.

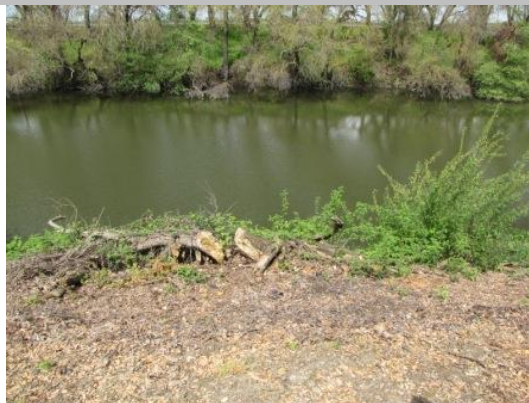
Photo 1 of 1 : SP_2017_RD0150_17_49_20170327_00031.jpg

LM Start	6.23	Rating **	N	Issue No.	49
LM End	6.23	Issue Type +	Ma	Location *	WS
Category	Earthen Levee			GPS Latitude/Longitude	
				Start	End
Item	Trim / Thin Trees			38.389658 °	38.389658 °
				-121.541518 °	-121.541518 °
DWR ID	DWR_RD0150_03_s_2012_49				
Comment Code					
T5 : Tree stumps.					
Inspector Comment

View of tree stumps on the waterward slope.

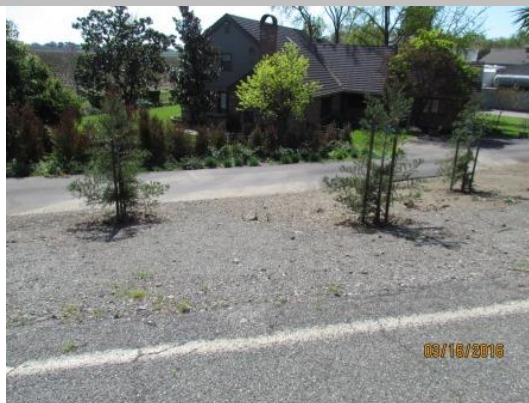
Photo 1 of 1 : SP_2017_RD0150_17_99_20170327_00077.jpg

LM Start	6.25	Rating **	M	Issue No.	99
LM End	6.25	Issue Type +	En	Location *	LS
Category	Earthen Levee			GPS Latitude/Longitude	
				Start	End
Item	Encroachments			38.389857 °	38.389857 °
				-121.541193 °	-121.541193 °
DWR ID	DWR_RD0150_03_s_2016_99				
Comment Code					
TR : Tree or limb					
Inspector Comment					
Newly planted tree on the landside slope of the levee.

View of newly planted tree on the landside slope of the levee.

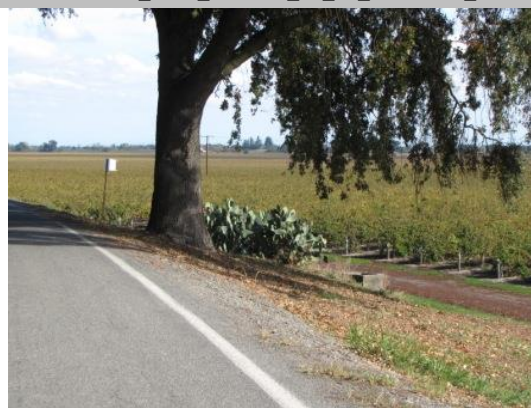
Photo 1 of 1 : SP_2017_RD0150_17_60_20170327_00041.jpg

LM Start	6.45	Rating **	M	Issue No.	60
LM End	6.45	Issue Type +	En	Location *	LS
Category	Earthen Levee			GPS Latitude/Longitude	
				Start	End
Item	Vegetation			38.391616 °	38.391616 °
				-121.538378 °	-121.538378 °
DWR ID	DWR_RD0150_03_s_2012_60				
Comment Code					
V6 : Landscaping					
Inspector Comment

View of landscaping along the landward slope.

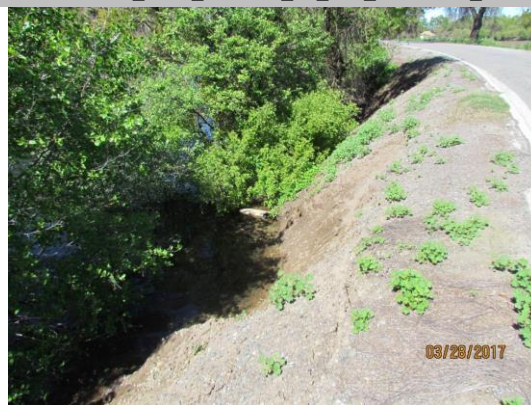
Photo 1 of 1 : SP_2017_RD0150_17_106_20170330_00150.jpg

LM Start	6.47	Rating **	M	Issue No.	106
LM End	6.47	Issue Type +	Ma	Location *	WS
Category	Earthen Levee			GPS Latitude/Longitude	
				Start	End
Item	Erosion / Bank Caving			38.391859 °	38.391859 °
				-121.538190 °	-121.538190 °
DWR ID	DWR_RD0150_03_s_2017_106				
Comment Code					
E1 : Note and monitor erosion site.					
Inspector Comment

View of an erosion on the waterside toe of the levee.

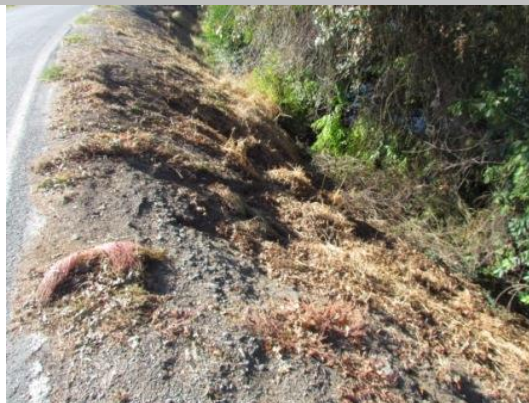
Photo 1 of 1 : SP_2017_RD0150_17_43_20170327_00027.jpg

LM Start	6.49	Rating **	M	Issue No.	43
LM End	6.49	Issue Type +	Ob	Location *	WS
Category	Earthen Levee			GPS Latitude/Longitude	
				Start	End
Item	Slope Stability			38.392172 °	38.392172 °
				-121.538065 °	-121.538065 °
DWR ID	DWR_RD0150_03_f_2012_43				
Comment Code					
S1 : Repair slope instability.					
Inspector Comment

Slope instability was found on the waterside of the levee looking downstream.

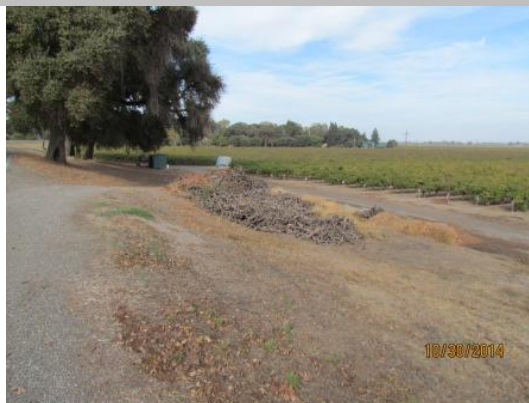
Photo 1 of 1 : SP_2017_RD0150_17_83_20170327_00063.jpg

LM Start	6.52	Rating **	M	Issue No.	83
LM End	6.52	Issue Type +	En	Location *	LS
Category	Earthen Levee			GPS Latitude/Longitude	
				Start	End
Item	Encroachments			38.392580 °	38.392580 °
				-121.538059 °	-121.538059 °
DWR ID	DWR_RD0150_03_f_2014_83				
Comment Code					
PR : Prunings					
Inspector Comment

Prunings were found on the landside toe of the levee looking upstream.

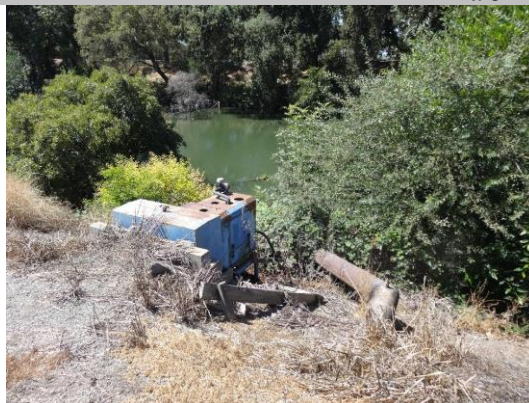
Photo 1 of 3 : UCIP_SP_2017_42692_35082.jpg

LM Start	6.63	Rating **	M	Issue No.	962
LM End	6.63	Issue Type +	En	Location *	LS
Category	Supplemental			GPS Latitude/Longitude	
				Start	End
Item	DWR UCIP Field Study			38.394182 °	38.394182 °
				-121.538609 °	-121.538609 °
DWR ID					
Comment Code					
Inspector Comment					
FS_ID:42692					
DS_ID:22457					
EP_NO: 14650					
Repair Type: Non-Urgent					
Crossing Status: Found					
UCIP Comments: Appears abandoned and if so should be done so properly.					
FIELD_STRUCT_DESC: 12-inch steel irrigation pipe through the levee, 5 feet below the crown. Concrete distribution box on landside levee toe. Diesel powered slant pump on water side. (Permit No. 14650 - Webber)					
FS Date: 8/23/2013

WS view: steel pipe (right) and diesel pump on levee slope.

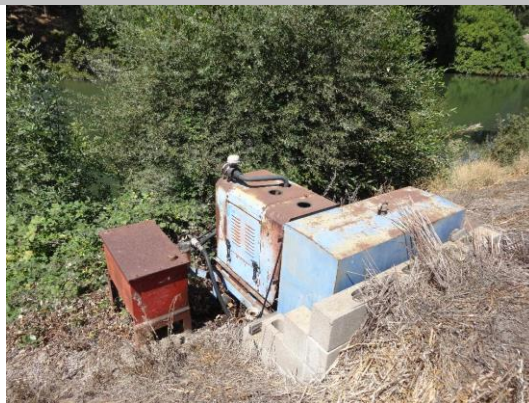
Photo 2 of 3 : UCIP_SP_2017_42692_35081.jpg

WS view: diesel pump on steep levee slope.

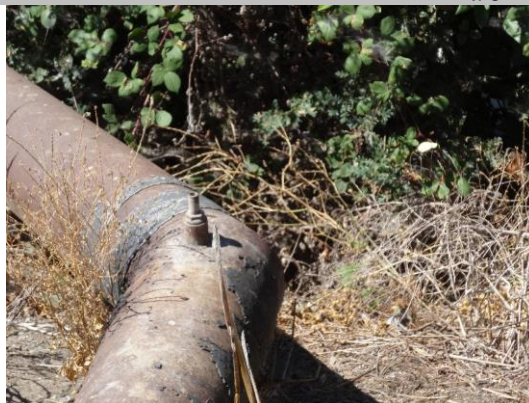
Photo 3 of 3 : UCIP_SP_2017_42692_35080.jpg

LM Start	6.63	Rating **	M	Issue No.	962 (cont)	
LM End	6.63	Issue Type +	En	Location *	LS	
Category	Supplemental			GPS Latitude/Longitude		
				Start	End	
Item	DWR UCIP Field Study			38.394182 °	38.394182 °	
				-121.538609 °	-121.538609 °	
DWR ID						
Comment Code						
Inspector Comment						
FS_ID:42692						
DS_ID:22457						
EP_NO: 14650						
Repair Type: Non-Urgent						
Crossing Status: Found						
UCIP Comments: Appears abandoned and if so should be done so properly.						
FIELD_STRUCT_DESC: 12-inch steel irrigation pipe through the levee, 5 feet below the crown. Concrete distribution box on landside levee toe.						
Diesel powered slant pump on water side. (Permit No. 14650 - Webber)						
FS Date: 8/23/2013

WS view: air vent on steel pipe.

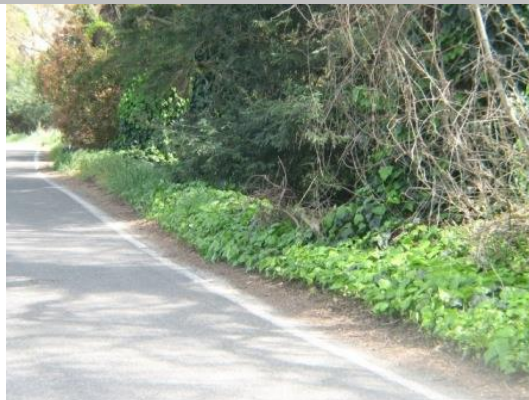
Photo 1 of 1 : SP_2017_RD0150_17_30_20170327_00016.jpg

LM Start	6.75	Rating **	U	Issue No.	30
LM End	6.83	Issue Type +	En	Location *	LS
Category	Earthen Levee			GPS Latitude/Longitude	
				Start	End
Item	Vegetation			38.395670 °	38.396027 °
				-121.537925 °	-121.536575 °
DWR ID	DWR_RD0150_03_s_2012_30				
Comment Code					
V6 : Landscaping					
Inspector Comment

Landscaping on landward slope blocking view from LM 6.87 to 6.95

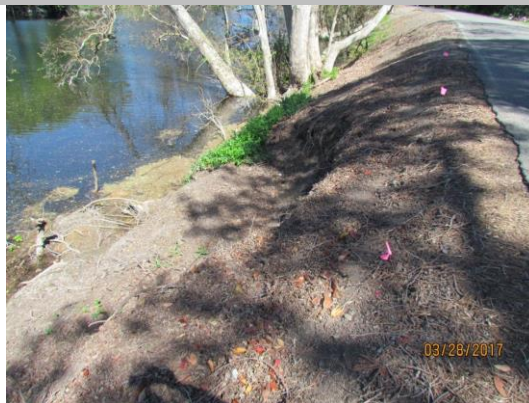
Photo 1 of 1 : SP_2017_RD0150_17_107_20170330_00151.jpg

LM Start	6.80	Rating **	M	Issue No.	107
LM End	6.80	Issue Type +	Ma	Location *	WS
Category	Earthen Levee			GPS Latitude/Longitude	
				Start	End
Item	Erosion / Bank Caving			38.395893 °	38.395893 °
				-121.537041 °	-121.537041 °
DWR ID	DWR_RD0150_03_s_2017_107				
Comment Code					
E2 : Schedule repair of erosion site prior to the next inspection.					
Inspector Comment

View of an erosion on the waterside slope of the levee.
